Manhole Inspection Summary

Manhole # S53C__016MH

Insp Date: **6/12/08 2:26 PM**

Location Address: **3107 e fairmount st**

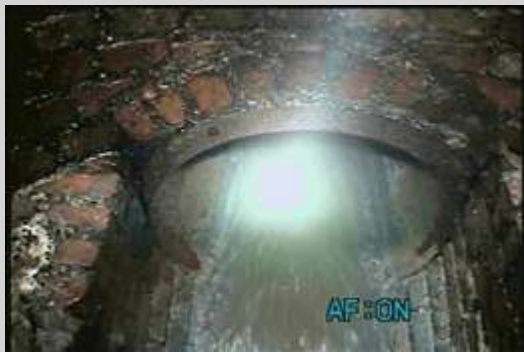
12 O'Clock Outflow

27 in. Circular Gravity Sewer
Pipe Out @ 12 O'Clock

Pipe Height: 0 (in.) Direct

Pipe Material: **Clay** ☐ Pipe Lined

Invert Depth: **16.09** (ft.) Flow Characteristics: **Fast**

Deposits: ☒ None ☐ Mud ☐ Sludge ☐ Debris ☐ Grease

Infiltration: **None** Pipe Seal Cond: **Unknown**

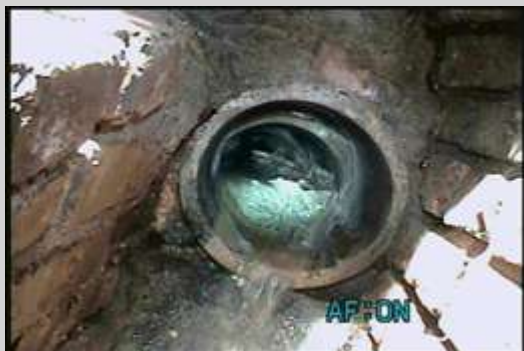
3 O'Clock Inflow

8 in. Circular Gravity Sewer
Pipe In @ 3 O'Clock

Pipe Height: 0 (in.) Direct

Pipe Material: **Clay** ☐ Pipe Lined

Invert Depth: **7.14** (ft.) Flow Characteristics: **Fast**

Deposits: ☒ None ☐ Mud ☐ Sludge ☐ Debris ☐ Grease

Infiltration: **None** Pipe Seal Cond: **Unknown**

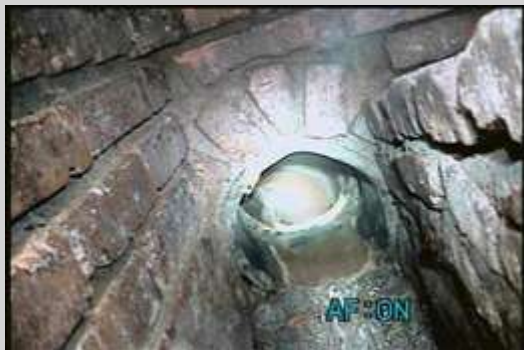
9 O'Clock Inflow

8 in. Circular Gravity Sewer

Pipe In @ 9 O'Clock

Pipe Height: **0** (in.) Direct

Pipe Material: **Clay** ☐ Pipe Lined

Infiltration: **None** Pipe Seal Cond: **Unknown**
